5.3. Street tree investigation reports

Re: High Cross Access Road, West Cambridge Site – Oak Trees

Tree Condition Survey

Charles Babbage Road Cambridge

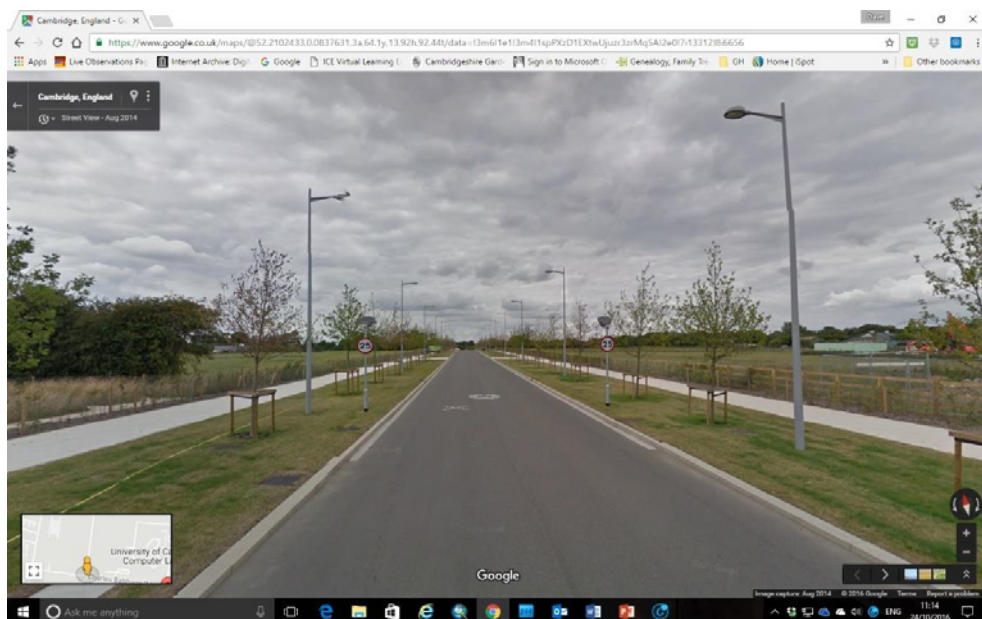
Google streetview contains images taken in August 2014 which show that the Oaks were already dead and dying stock at that time. I inspected the Oaks on August 4th 2014 at the request of Pro-scape, who were concerned about the deaths and dieback on the Oaks. Photographs taken by Pro-scape at the beginning of July 2014 show the trees beginning to flush into leaf.

At the time of my visit in August 2014 the tree pit soils appeared to be dry and there had been two weeks of dry weather. The damage appeared to be consistent with lack of water due to drought conditions and I recommended watering to make soil water available. No trees were lifted at that time.

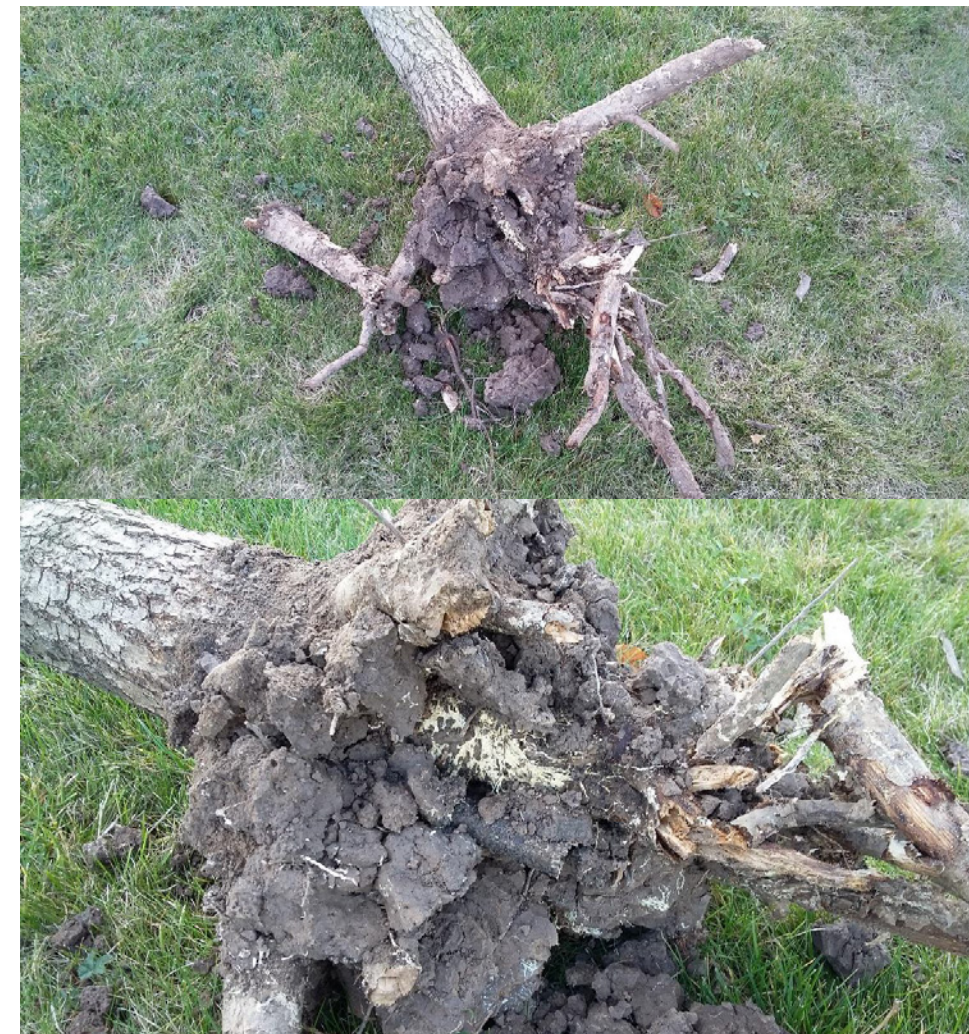
The rootball was of a dense blue-grey with orange flecks (gleyed) clay which was somewhat stiff but still plastic. It was less than 600mm in diameter. When the clay was peeled back, the exposed root system showed extensive soft rot with blackening beneath the dead cortex in places, which was slimy to touch. There was an absence of discernible fine root and the root system was of short severed roots 15-25mm diameter.

From observation of the decayed root system within the small clay rootball it seems likely that the stock was already in poor condition when supplied to site. If the trees were undercut and lifted in Winter 2013/14 then the inadequate root systems would not have been stressed before planting and would have enough energy to flush into leaf, albeit rather late and weakly in many cases as can be seen below.

disturbance or severance of the root system. The safest course of action, in my view, would be to replace with container grown trees of another species at a smaller stock size but to the original tree pit and furnishings specification. Regular watering and monitoring of soil water (moisture content) using Frequency Domain Reflectometry is becoming more widely used. This equipment can take the guesswork out of watering landscape planting beds, which for expensive materials is probably justified. Suitable species which are worth considering for the avenue are:

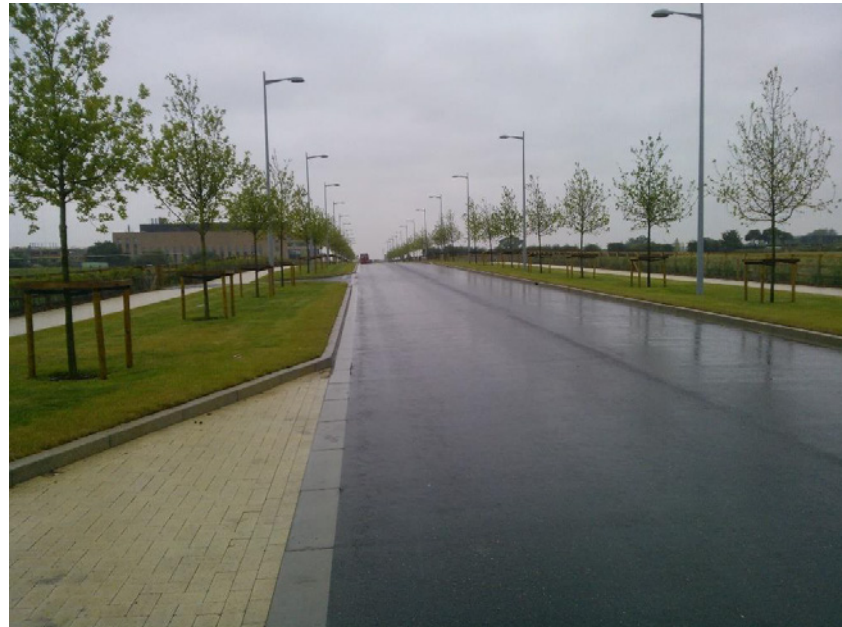
Photograph taken by Pro-scape in the first week of July 2014

The only likely causal factor in the decline and death of the Oak trees is therefore the original stock quality as delivered to site. The nature of the defect is that, other than the small size of the rootballs, it would not be evident at the time of delivery to site. The surrounding soils are of very good quality for a landscape site and are not a contributory factor. The dry conditions in July 2014 were not prolonged and although the surrounding soils were relatively dry, the scale of effect and the slow coming into leaf shown in the July photograph indicate that the trees were already failing to thrive.

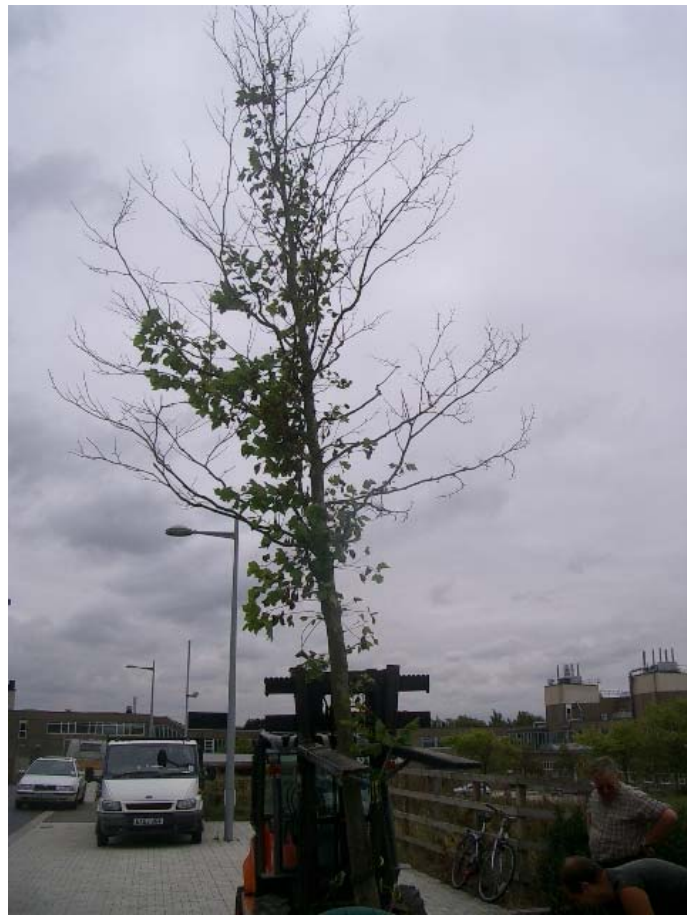
Tree 1 is a severely damaged example with total canopy death and some vigorous re-growth around the trees main stem. Removal of the tree pit exposed a partially dead root system and a largely dry root ball. Root growth in the top 300mm of the root ball was alive and had

It would appear from the size and development of roots outside the original root-ball that for at least two growing seasons root growth was sustained by the tree. Root activity then declined and a significant proportion of the trees root system declined or died. At this point the tree probably defoliated early and produced less and fewer leaves during the following spring flush. The edges of the canopy then died back, resulting in a tree which was severely damaged. During this period of drought stress the upper part of the trees root system was able to survive on the prevailing rainfall and perhaps an erratic watering regime. Recent rainfall appears to have boosted growth which is now dense but restricted to the trees main stem. Despite this apparent renewed vigour the tree will not provide a satisfactory specimen.

Tree 1 partial re-growth around trees main stem

- 5.1 All of the trees in phase 1 should be replaced once a maintenance regime has been devised that provides the information outlined at 5.2 and enables an appropriate watering regime to be implemented.

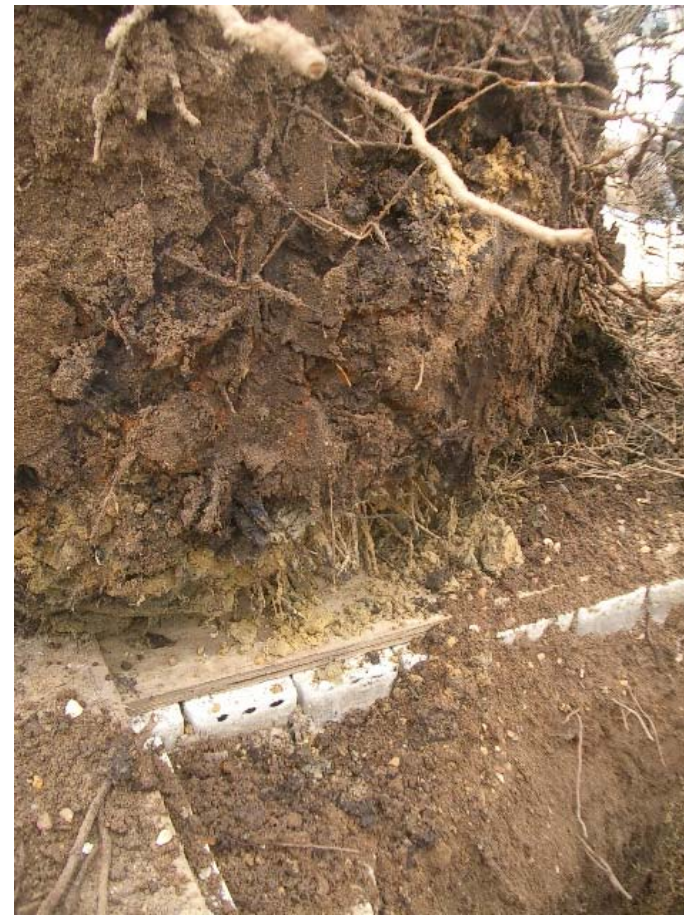
Tree 2 is a completely dead tree. Removal of the tree from the tree pit exposed a completely dead root system. As with tree 1 there is evidence of good root growth which occurred during the first two growing seasons. Drought stress caused by the erratic availability of soil moisture appears to have lead to a more dramatic decline and eventually the failure of the tree. It was noted during the excavation process that the base of the tree pit appears to have been waterlogged sufficient for the anaerobic conditions to have developed. The volume of soil affected is relatively low and is unlikely to have contributed to the demise of the tree. The pit was not waterlogged when it was excavated despite higher than average rainfall in August and the fact that the tree was not removing moisture form the tree pit because it was dead.

Tree 2 discoloration indicating some water logging of root-ball base

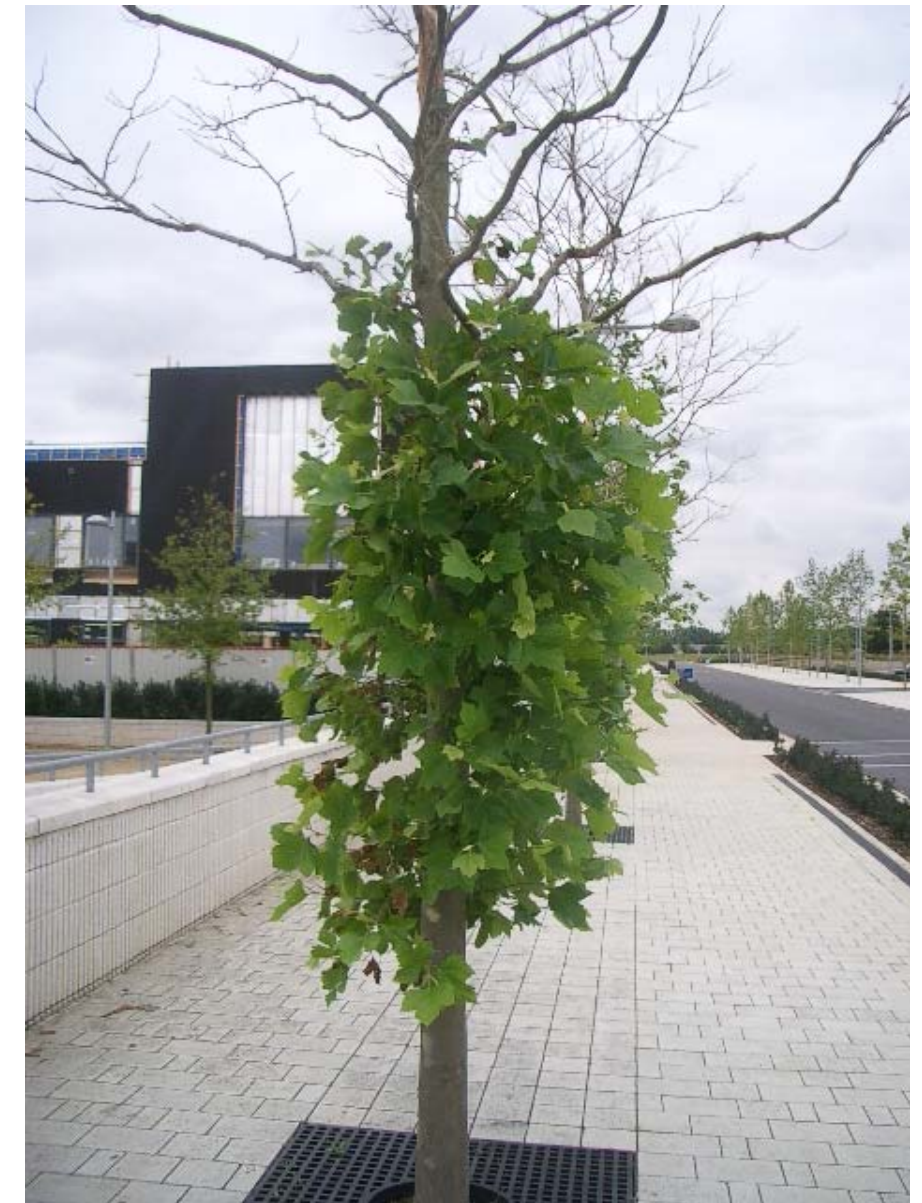
Tree with growth restricted to main stem, some evidence of drought stress in browning of leaf margins.

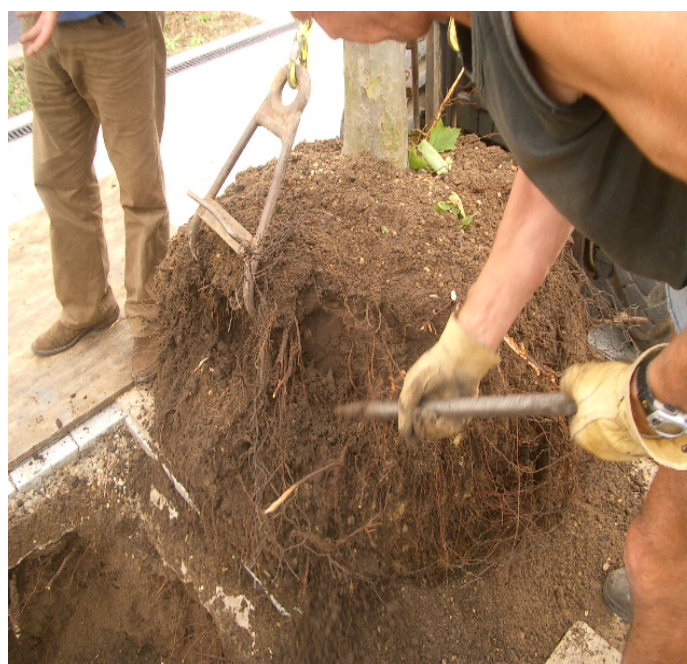
extended beyond the original root ball into the tree pit back fill (Amsterdam Tree Soil). Root activity below 300mm appeared to have been good but was dead. Current growth appeared to be being sustained but was beginning to show signs of drought stress as some leaves were browning at the edges.

Tree 1 fibrous root growth in top 300mm of root ball
Dead roots at base of root ball

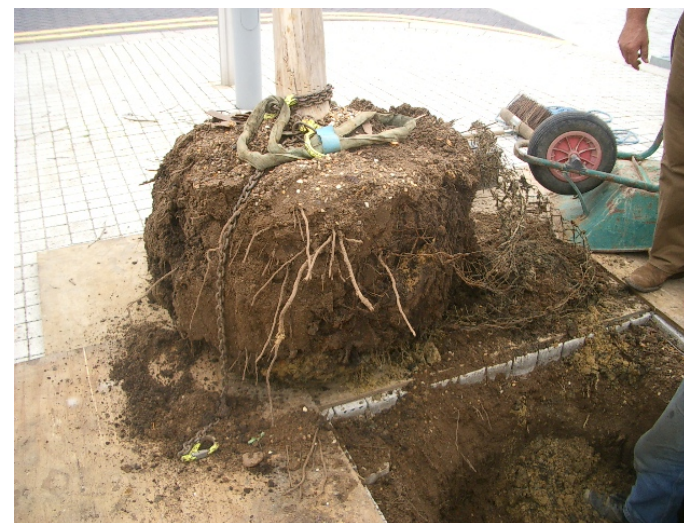
Tree 2 showing reduced root activity than tree 1

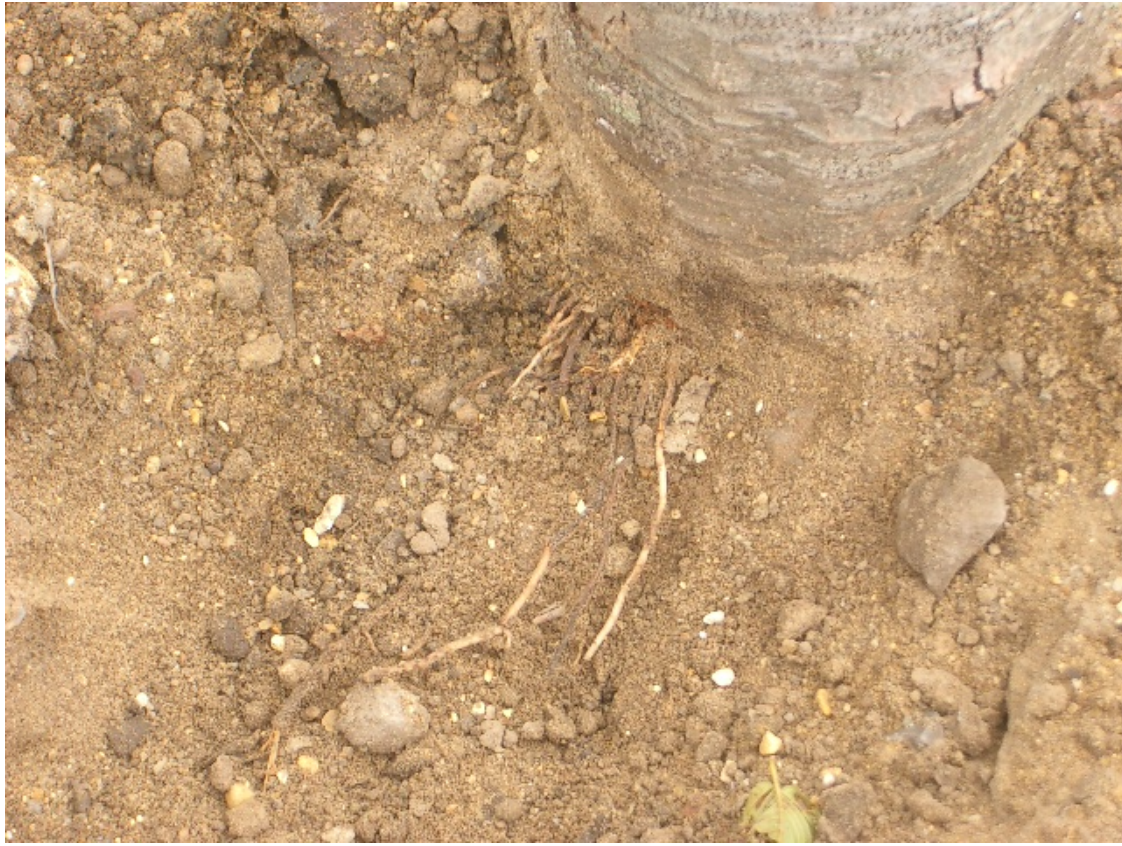
- The material excavated from the top of the tree pit appeared to be railway ballast mixed with topsoil.
- The tree was planted to a depth such that the root/stem collar was 200mm below the surface. New roots had developed from the buried main stem of the tree.
- The area adjacent to the trees root ball was probed with a ranging rod. Virtually no soil adhered to the pole and the material that did was dry.
- There was no evidence of water logging or anaerobic conditions.
- It would appear that a combination of incorrect planting depth and erratic watering is contributing to the current condition of the trees.

Phase 2 planting showing development of roots on main stem of tree planted too deep

- 5.3 The trees in phase 2 appear to be suffering from an erratic watering regime and being planted too deep. The impact of the back fill material has not been considered. The origin of the material should be confirmed by the landscape contractor and if the answer is unsatisfactory the material should be screened and the PH checked. In order to improve the current condition of the trees the following action should be taken:
- Fill levels within the tree pit should be reduced to the top of the root ball. The resultant void between root ball and tree grill could be filled with an inert coarse material.
 - The watering regime should be assessed and adjusted to take account of rainfall and tree pit drainage.
 - Roots which have developed from the main stem of affected trees should be removed.
- 5.4 Soil levels around trees planted in open beds should be checked and adjusted as necessary.

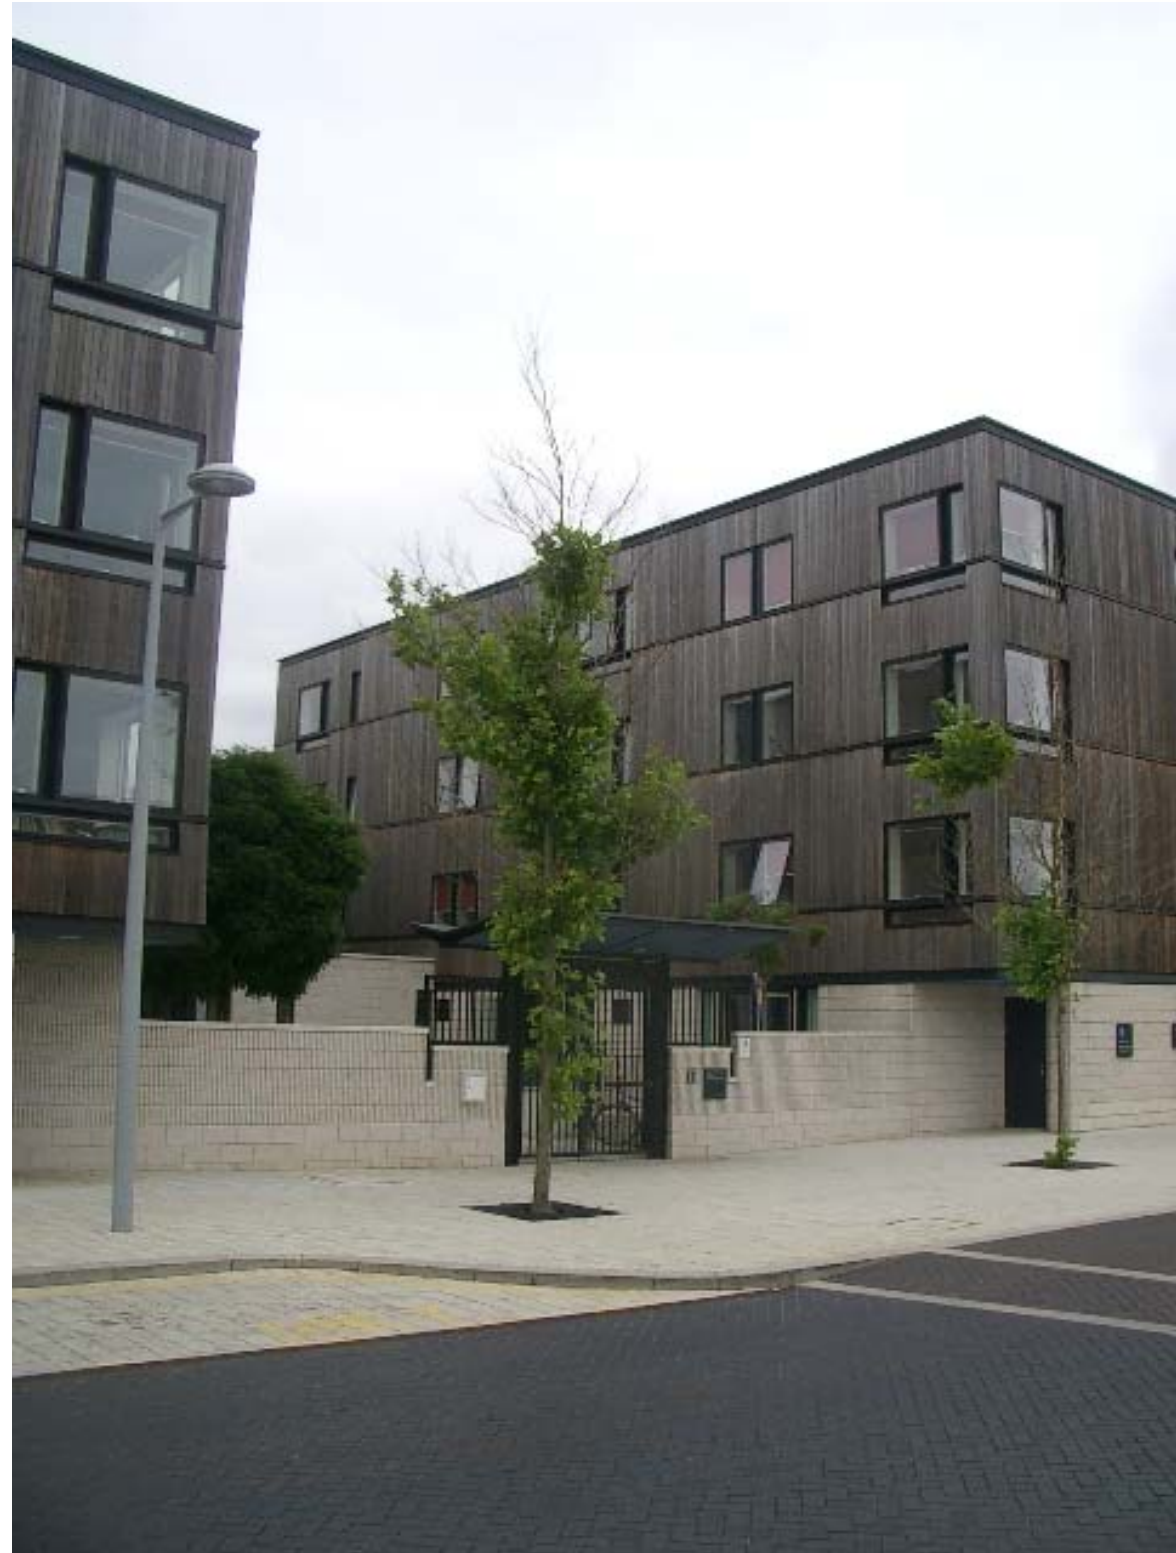
- 3.2 The trees in this phase are in the poorest condition several of which are completely dead. The trees which are alive vary in terms of their condition and it is unlikely that any trees within this phase of planting will develop into acceptable specimens. Two trees were excavated from this phase of the planting as follows:

Phase 1 planting showing die back and re-growth
