WEST CAMBRIDGE

OUTLINE PLANNING APPLICATION

HERITAGE ASSESSMENT

MERTON HALL FARMHOUSE AND THE DEPARTMENT OF VETERINARY MEDICINE

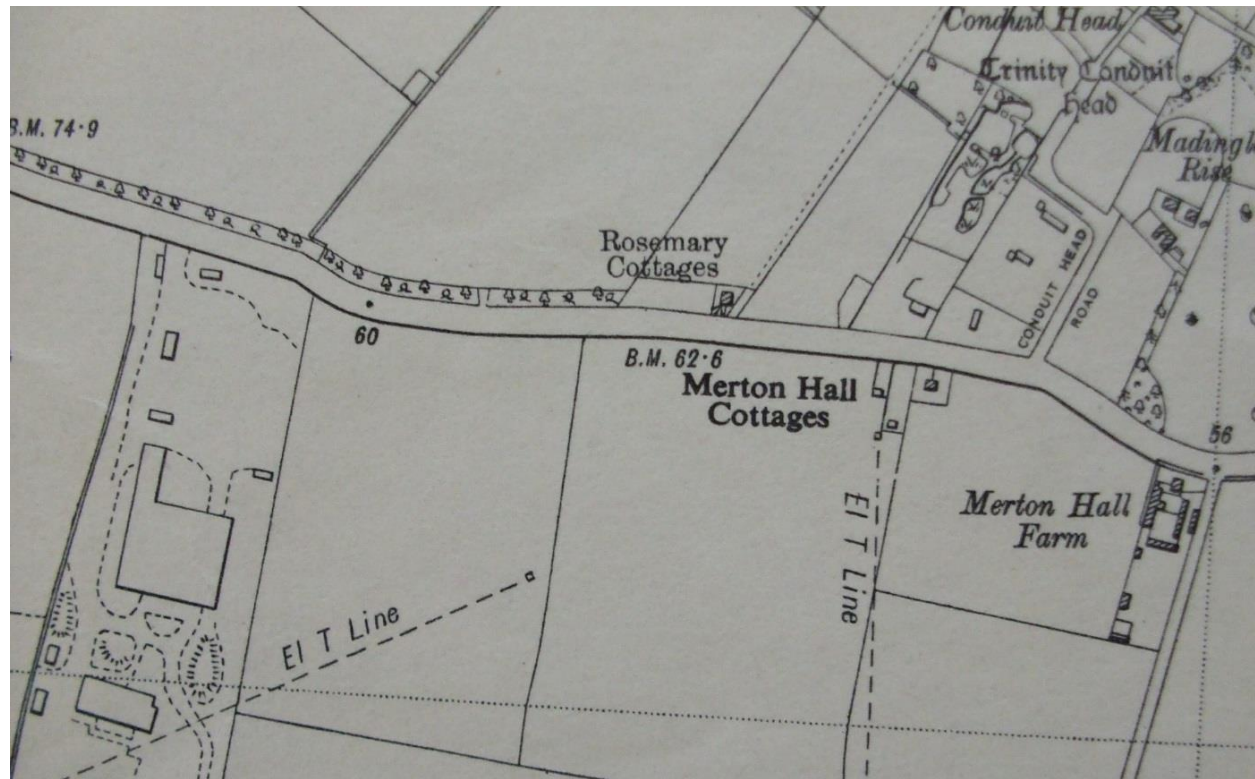
Figure 3.3 1:10 560 Ordnance Survey Map, with additions in 1950

3.2.4 By the time of the OS mapping of the immediate post-war period, the development of the area to the south of Madingley Road by the University is becoming evident. The 1950 revisions of the mapping show a large building to the west of Merton Hall Farm, and another to the south (see Figure 3.3, the latter building is not visible in this Figure). It isn't until the 1970s that the Department of Veterinary Medicine first appears on the OS maps, labelled as the “University of Cambridge School of Veterinary Medicine” on the 1970 and 1972 maps (Figure 3.4). By this time, the map also shows change to Merton Hall Farm, coinciding with its acquisition by the University. A number of larger buildings have been constructed to the south of the farmhouse, with the distinctive rectangular arrangement of buildings around the farmyard, evident in previous mapping, no longer clearly visible. The maps show that a north-south aligned driveway was constructed from Madingley Road to the entrance of the Vet School to provide access, while the north-south aligned road to the east of Merton Hall Farm remained.

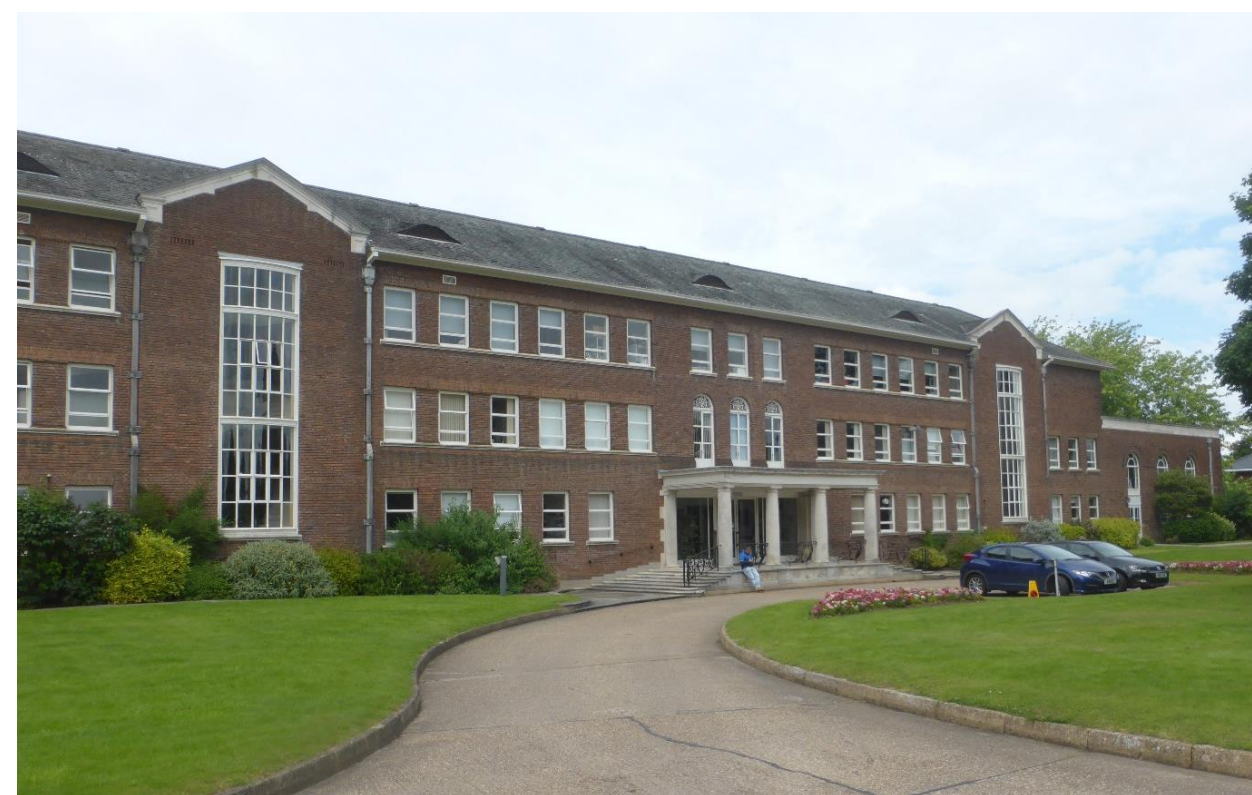
- 4.1.10 The east façade of the Teaching Block is designed as the principal façade, with the entrance to the department central to it (Figure 4.1). The façade consists in total of thirty-two bays, though these are not all regularly spaced. The majority of the façade is three storeys with an additional storeys housed within the attic. The southern three bays rise to five storeys, and the northern three are two storeys with double height windows, housing a lecture theatre. The façade is symmetrical in its centre, between the two staircase bays. This central part has fifteen bays consisting of a central three bays over the central portico, with arched windows on the first floor, with six bays either side. The ground floor has a blind bay on each side to accommodate the central portico and stepped entrance. Beyond the staircase bays at either end of the three storey section, the façade differs. At the north end are three regular window bays, the third storey of which are blind, to the north of which is the lecture theatre. At the south end of the building, to the south of the southern staircase bay, are five regular window bays with an additional blind bay to the south, beyond which is the five storey section, of three bays (the southern-most of them blind).

Figure 4.1 Vet School Teaching Block, principal east entrance façade

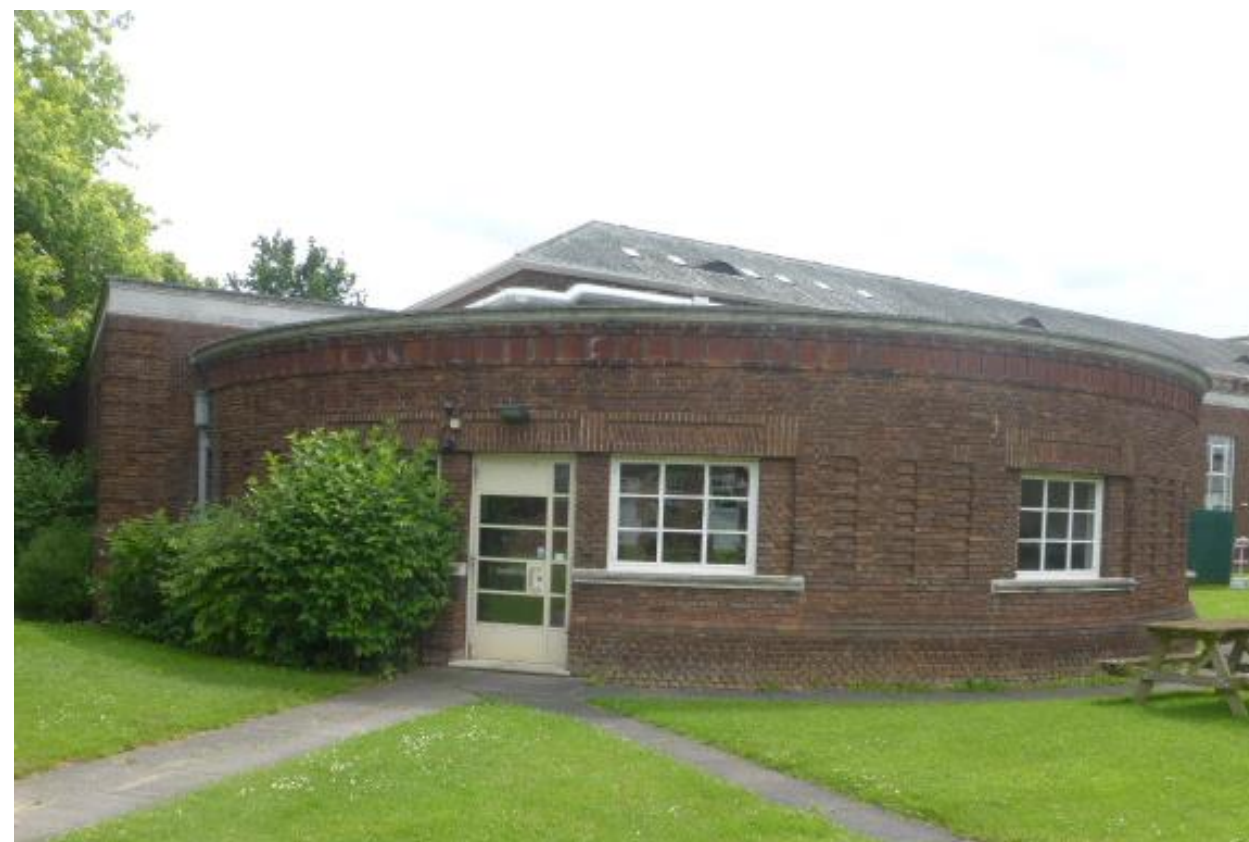
- 4.1.17 The curved western façade of the semi-circular SCR at the rear of the building (Figure 4.2) has decorative recesses with staggered brick, and the plinth and dogtooth decoration are at the same height as on the northern lecture theatre. The façade has two metal frame glazed doors, with five nine light metal frame windows, one on either side of each door, and three located centrally. Each window has a stone sill and decorative brick flat arches. A decorative frieze of tiles beneath raised brickwork, and a small moulded Portland stone cornice, form the parapet. Between the windows are recessed features, matching those on the north façade of the lecture theatre. The hoppers on the downpipes are somewhat more decorative than those on the other façades, reflecting the status of the room.

Figure 4.2 Vet School Teaching Block, west elevation of Senior Common Room (SCR)

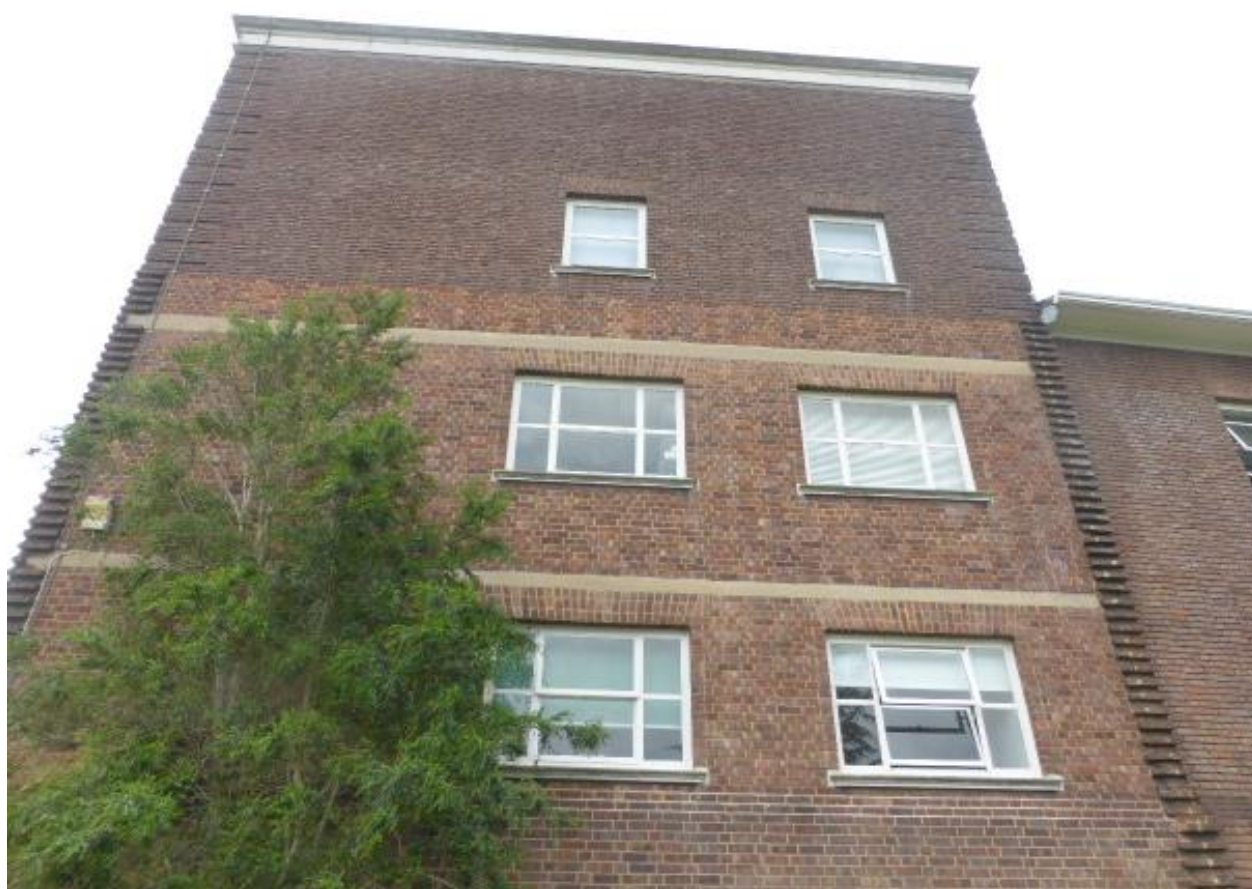
- 4.1.19 The five storey south section of the Teaching Block is treated slightly differently to the rest of the building. This is partly due to the original intention to build a three storey eastern wing extending from the front of the façade, and is indicated by the staggered brick courses running vertically up the eastern façade, below the fourth floor (Figure 4.3). The brickwork on the lower three floors between the staggered wall stubs is also of a cheaper quality than elsewhere, lighter in colour with a less textured surface and with concrete string courses between floors. The flat arched windows have uncut bricks and staggered soffits, while the metal framed windows themselves are larger than those of the rest of the east façade, aside from on the third floor.

Figure 4.3 Vet School Teaching Block, southern section east façade. Note the poor quality staggered brickwork, which detracts from the façade

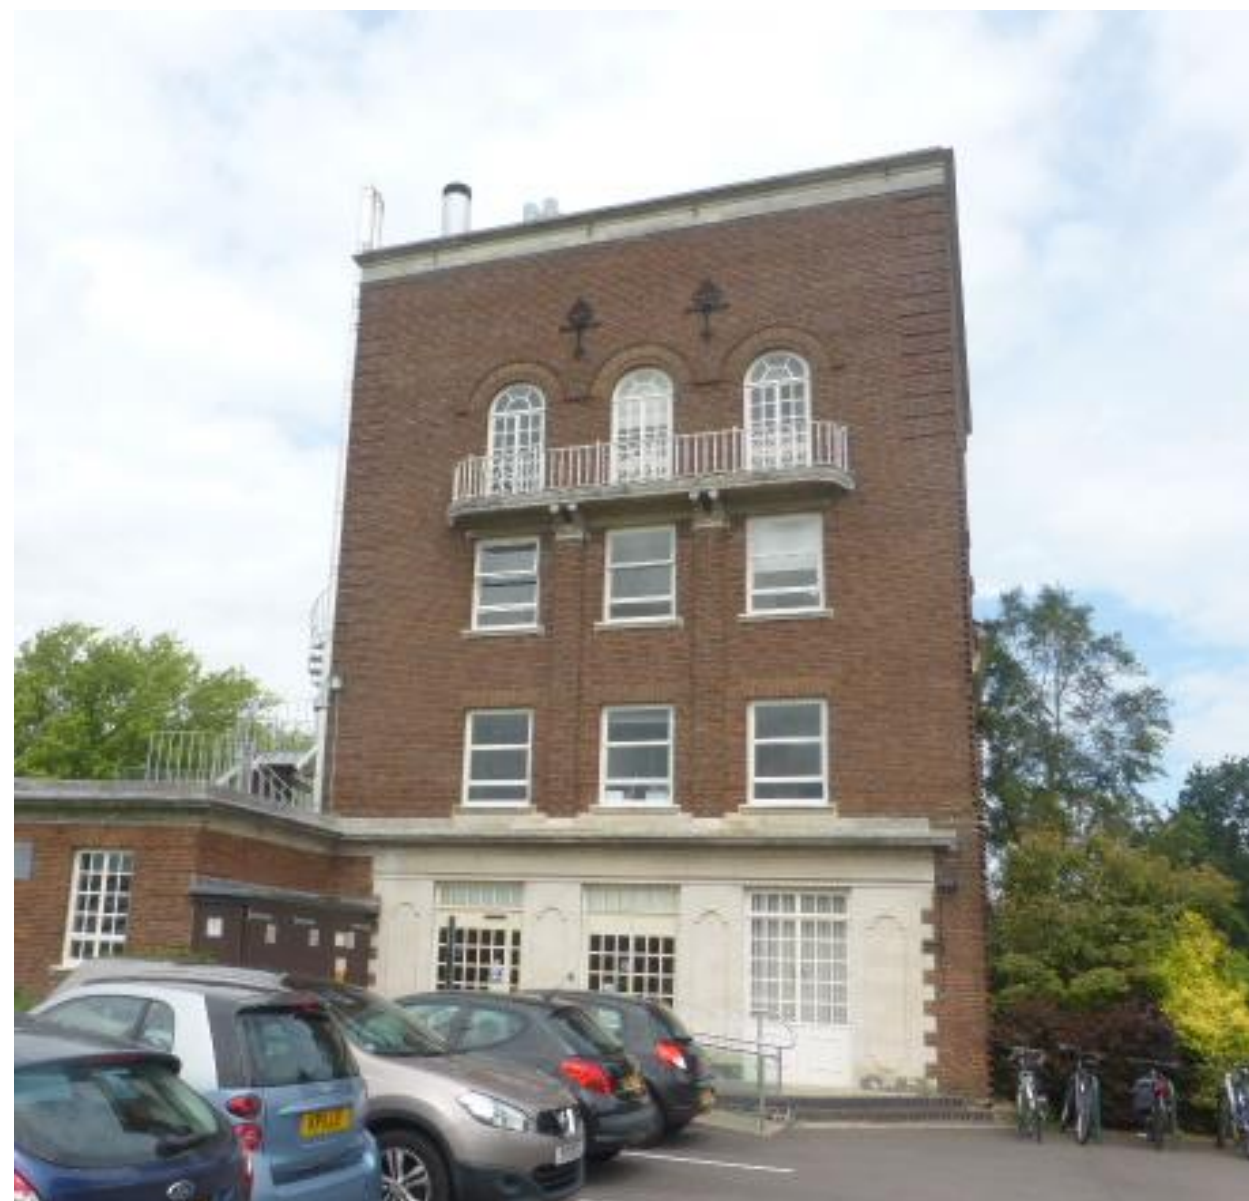
- 4.1.20 The three bay south façade of the building, at the south end of the five storey section, has different decoration from the other elevations (Figure 4 4). The ground floor is faced with Portland stone rather than brickwork, with five classically styled panels either side of and between the windows, and a plain entablature below the first floor windows. Above this the façade is brick. The third floor has arched French windows, leading onto a stone balcony, with white painted iron railings. There are metal tie plates on the south and west facades of the five storey section, above the third floor windows.

Figure 4.4 Vet School Teaching Block, southern section south façade

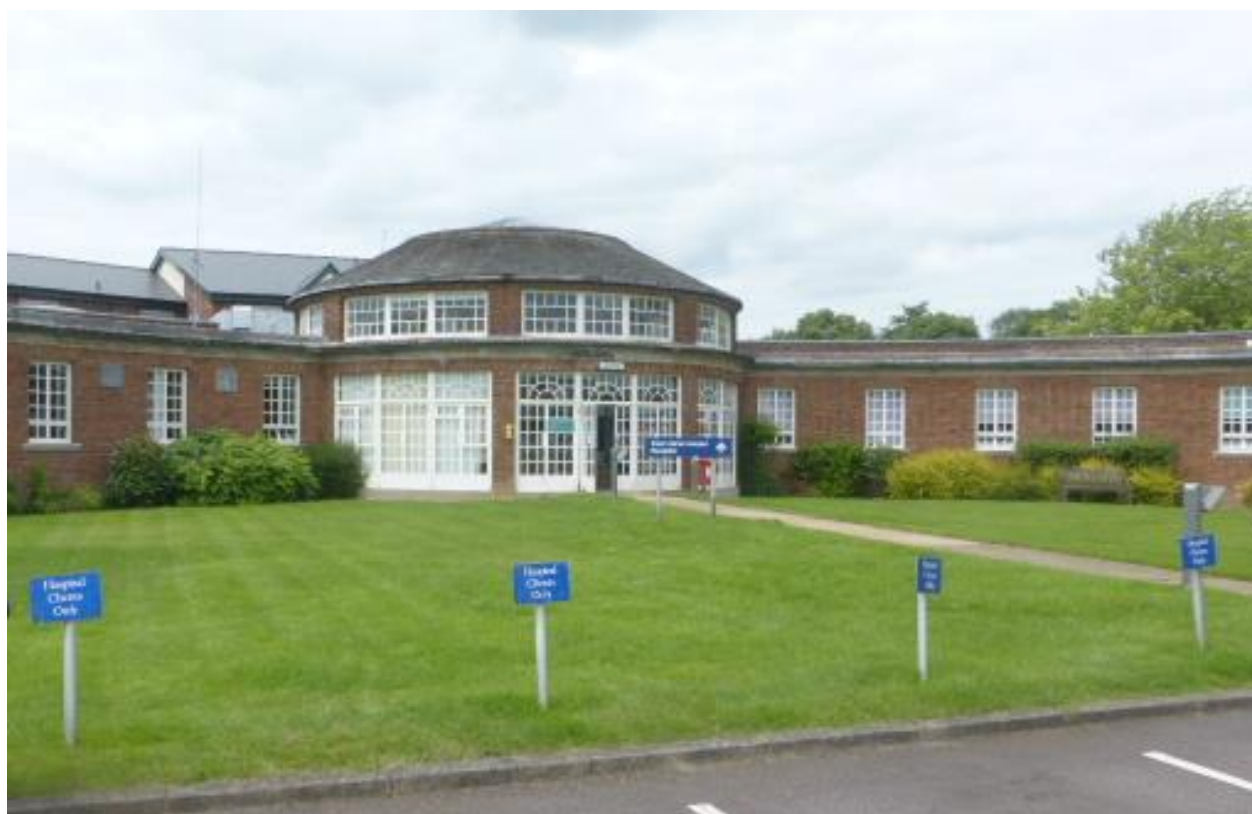
- 4.1.21 The front, east façade of the Hospital Block (Plate 5) has nine bays either side of the central rotunda, with the northern of a pair of lodges at the southern end of the building, and the curved façade connecting to the Teaching Block at the northern end. The central rotunda has three structural bays on the front facade. The hospital has a stone cornice on the wings, which forms a string course across the rotunda. The brickwork of the Hospital Block is the same throughout; laid in a variation of Flemish bond with two stretchers between each header, so that the headers sit over the perpend between stretchers (Monk Bond).

Figure 4.5 Vet School Hospital Block, principal east façade

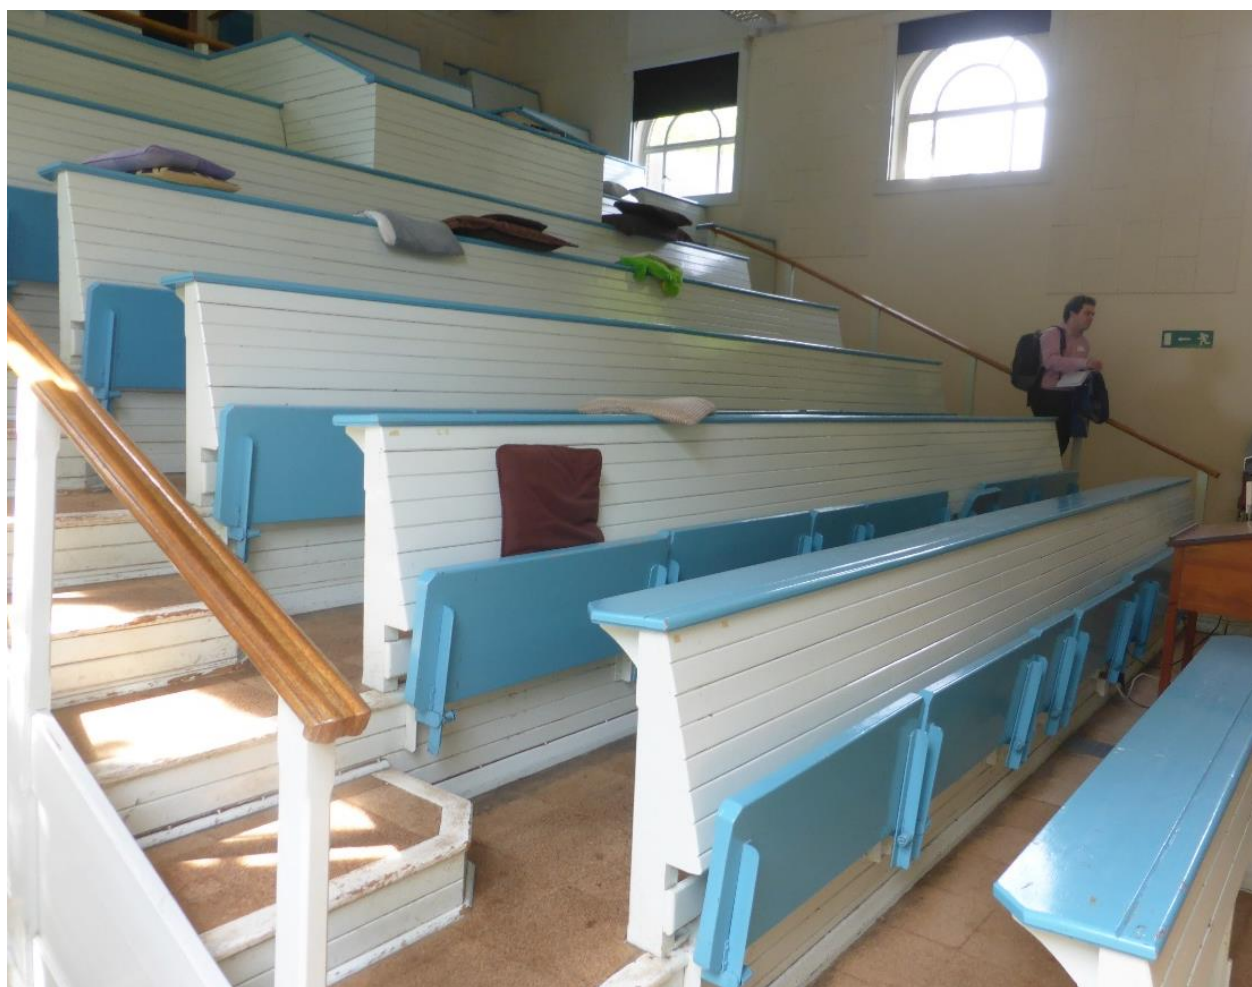
4.1.28 The lecture theatre at the northern end of the ground and first floor of the Teaching Block (Plate 7) is original whereas those adjacent to it along the west wing corridor have been altered considerably or are completely modern installations. A number of original features have been retained within the lecture theatre. The room has metal tall framed windows on the east side of the room with matching high level arched windows on the western wall. Sound-absorbent polystyrene wall and ceiling tiles may be original, as may be the cork flooring. The tiered seating has tongue and groove horizontally set boarding, with spring tip-up seats and long desks. There is an original projector pit in the middle of the seating. The end of each row of seating has recessed panels. To the rear of the lecture theatre, high level double doors give access to the first floor corridor. Store rooms are located on either side of the podium, designed to direct views inwards towards the lecturer and blackboards. The timber desk on the podium and the blackboard both appear to be original. The lighting on the ceiling dates from the mid-1990s, as with that in the SCR, while modern additions have been made to the podium end, with white boards, additional projection facilities and sound system installed.

Figure 4.7 Vet School Teaching Block, lecture theatre

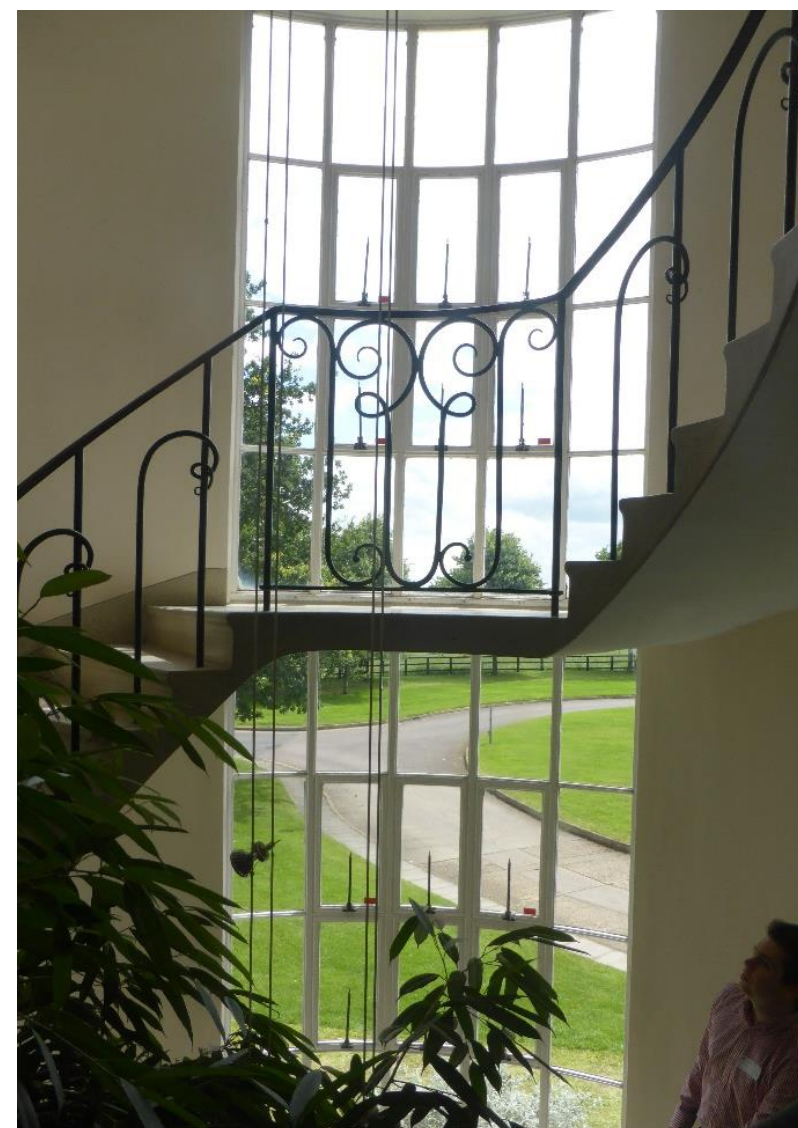
4.1.29 Two identical (though mirrored) spiral staircases with central wells, providing access through all floors of the Teaching Block, are located on the east side of the main corridor. Each are lit by vertically proportioned twenty light curved metal framed windows, continuous to the height of the stairwell (Figure 4.8). The staircases themselves are constructed of thin concrete, with tubular steel banisters, the uprights of which are decorated with finial vine motifs, each folding back onto the previous upright. Each stair has terrazzo style inserts. Originally, the staircases would have opened directly onto the corridors, but recently glazed timber framed partitions and double doors have been added. The partitions are curved to match the curve of the staircase.

Figure 4.8 Vet School Teaching Block, northern staircase

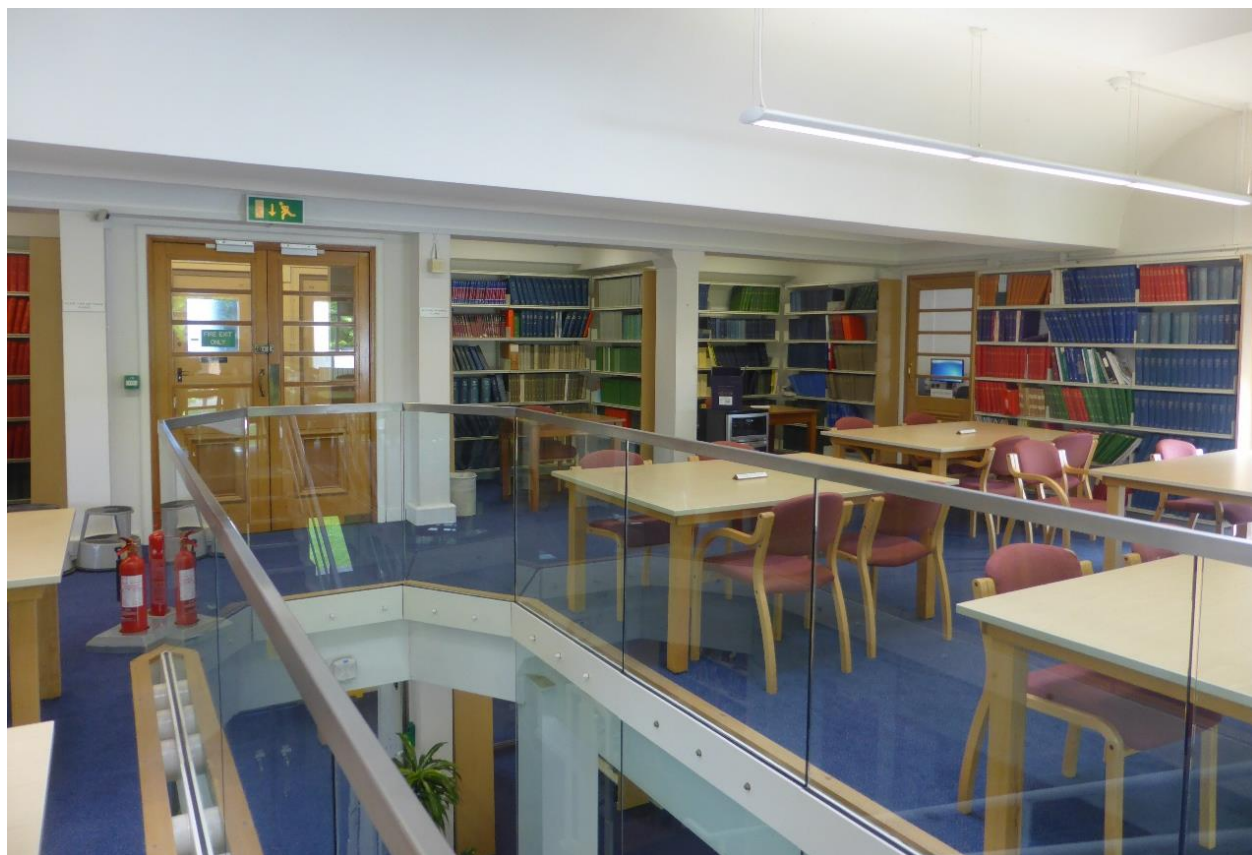
4.1.30 Located centrally on the ground floor, opposite the entrance lobby, and projecting outwards to the rear of the building, is the departmental library. This is in its original position, but it was heavily reconfigured in the year 2000. The original narrow first floor gallery and spiral staircase were removed, and a central straight staircase added, with the first floor being extended over most of the space (Figure 4.9). This has compromised the sense of space and restricted the light which would have been offered by the original design. A glazed partition with glazed doors provide access from the main corridor. The first floor ceiling has a central longitudinal north-south arch with square skylights. The glazed timber double doors upstairs are original, as are the metal framed windows.

Figure 4.9 Vet School Teaching Block, library, showing altered configuration with new first floor and staircase

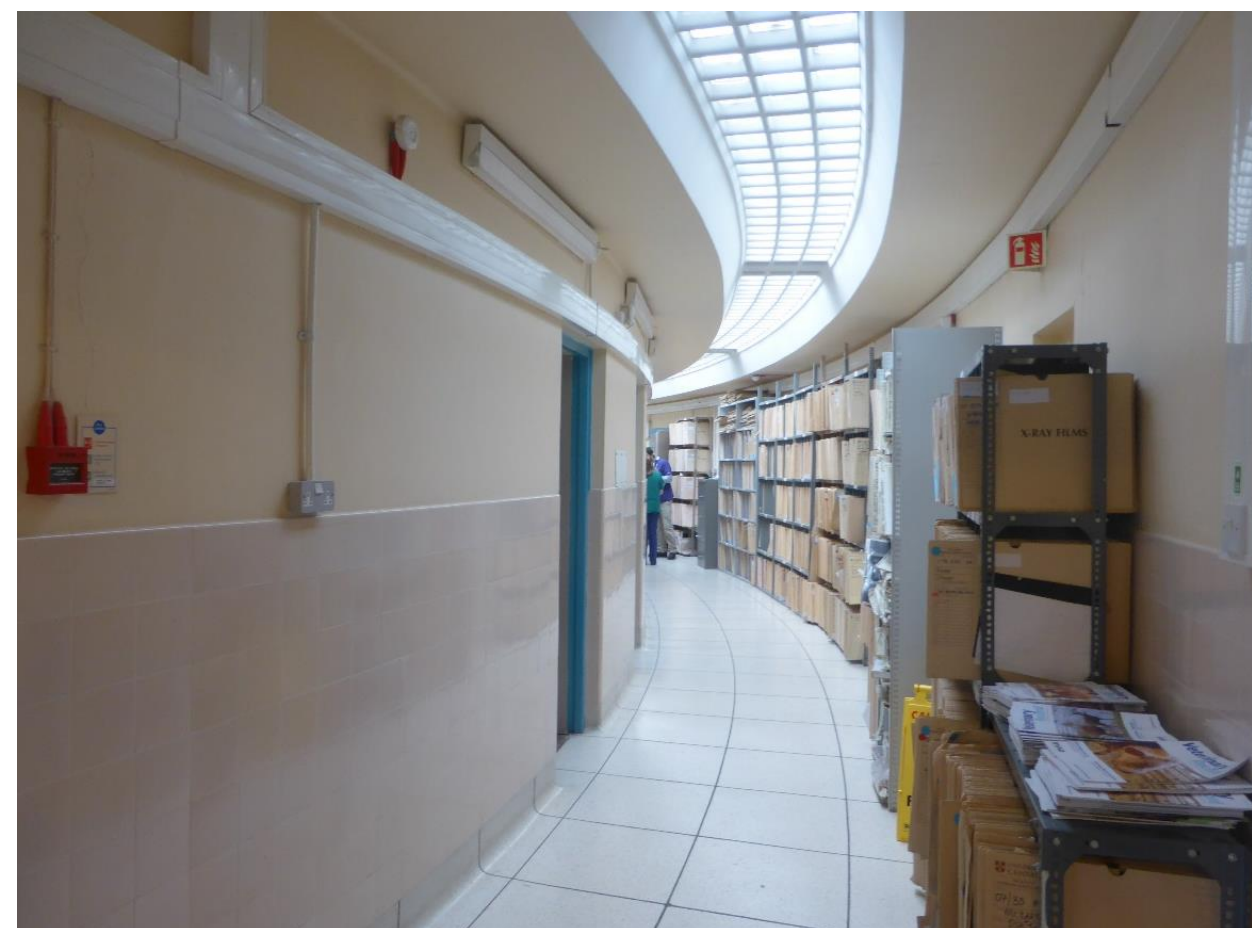
- 4.1.35 On the ground floor, the central longitudinal curved corridor of the Hospital Block (Figure 4.10) is lit by a continuous three light wide recessed basement pavement type skylight. Terrazzo flooring extends the length of the corridor, with swept margins to facilitate cleaning; above are eight courses of glazed wall tiles extending to dado height. The junction of the walls and ceiling of the corridor have a slight curve. The timber glazed doors from the corridor of the Teaching Block into the Hospital Block are original. The offices along the corridor would have originally all had parquet flooring, though this has been removed in a number of them for reasons of medical hygiene.

Figure 4.10 Vet School Hospital Block, main corridor

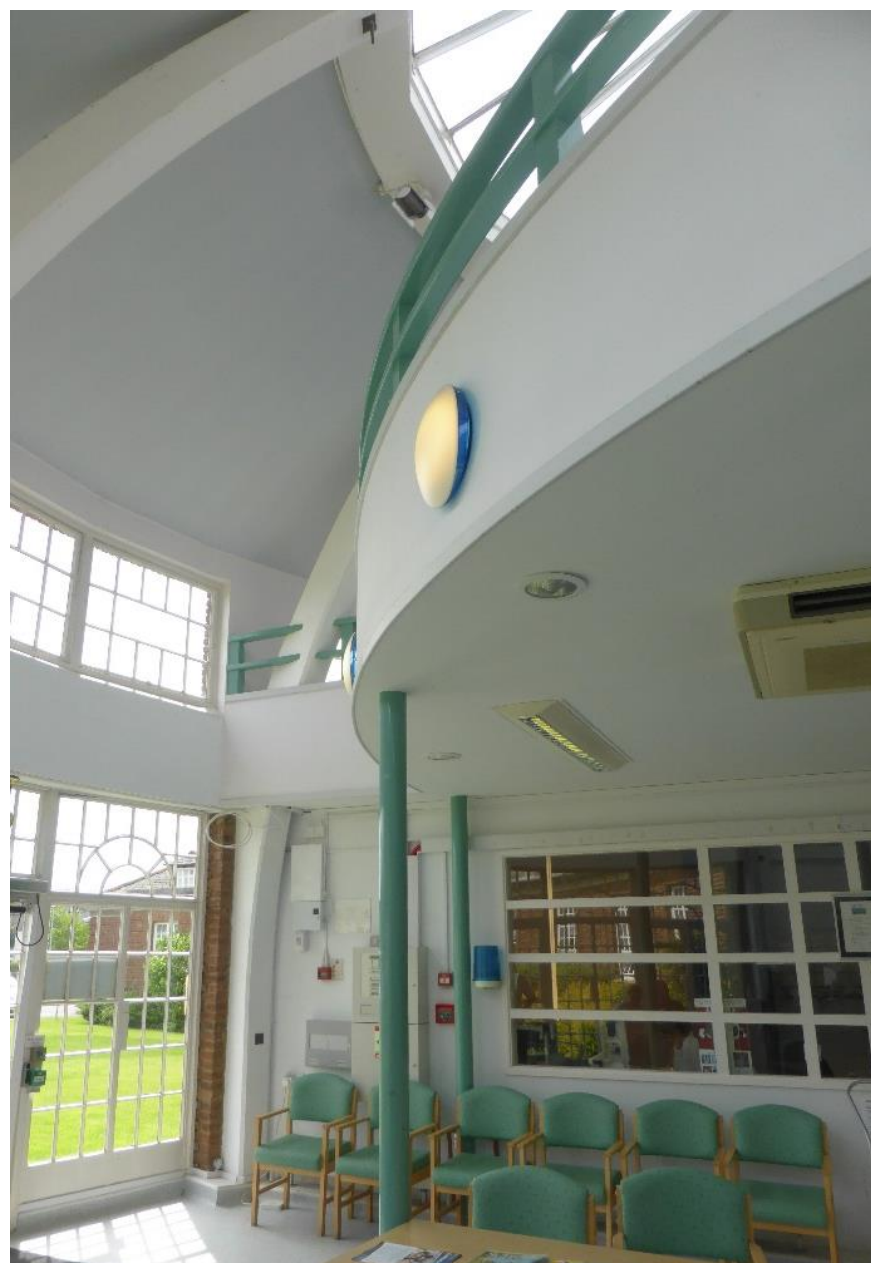
4.1.36 The rotunda at the centre of the Hospital Block is currently the reception area for the Small Animal Hospital, and has been reconfigured from its original spatial arrangement, with a galleried first floor added across part of the space, supported on steel posts though the reception area itself remains largely open (Figure 4.11). The rotunda is constructed of reinforced concrete, with eight frame posts visible and a reinforced concrete beam extending around the space between the low and high level windows. Towards the top of each frame post is an original metal ring, used for supporting animals, when the hospital was used for larger animals (the space may have originally been used for equine examination). The current reception desk is below the galleried first floor. There is a large octagonal ceiling skylight, with metal framed triangular lights and a central boss and the inserted first floor is further lit by the original clerestory triple twelve light windows between the frame posts above the taller ground floor windows lighting.

Figure 4.11 Vet School Hospital Block, rotunda interior, showing alterations made for accommodation of the Small Animal Hospital reception area

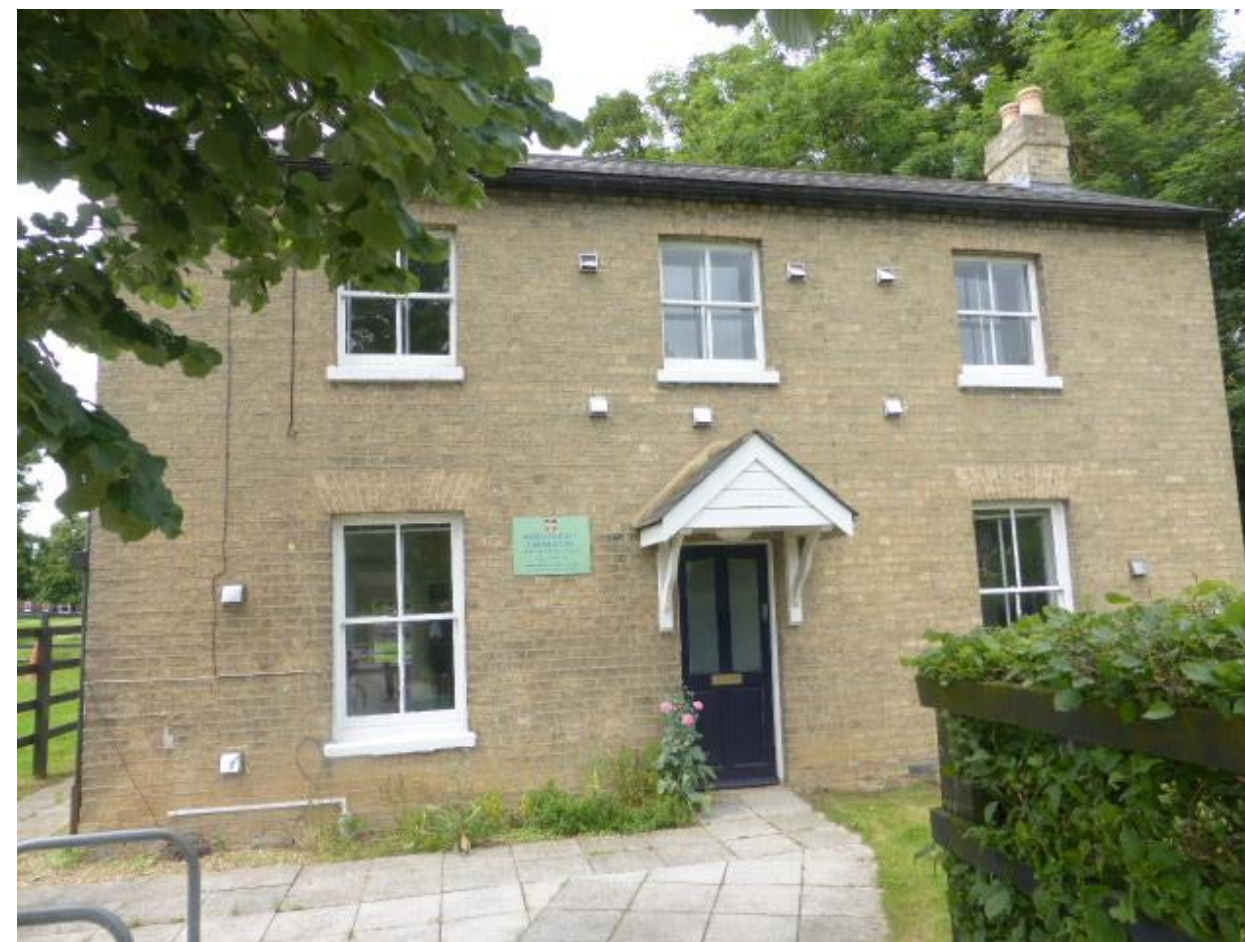
Figure 4.12 Merton Hall Farmhouse, principal east façade. Note the additions of vents, detracting from the quality of the façade

4.2.2 The front façade is symmetrical, with four light sash windows under brick flat arches and stone sills beneath. The front door has a simple bracketed and weatherboarded gabled porch, with a slate roof. The doorway has a much worn York stone threshold. Vents have been added to front brickwork, an addition which involved the removal of sections of the original brickwork; the vent openings and their reflective finish detract from the façade.

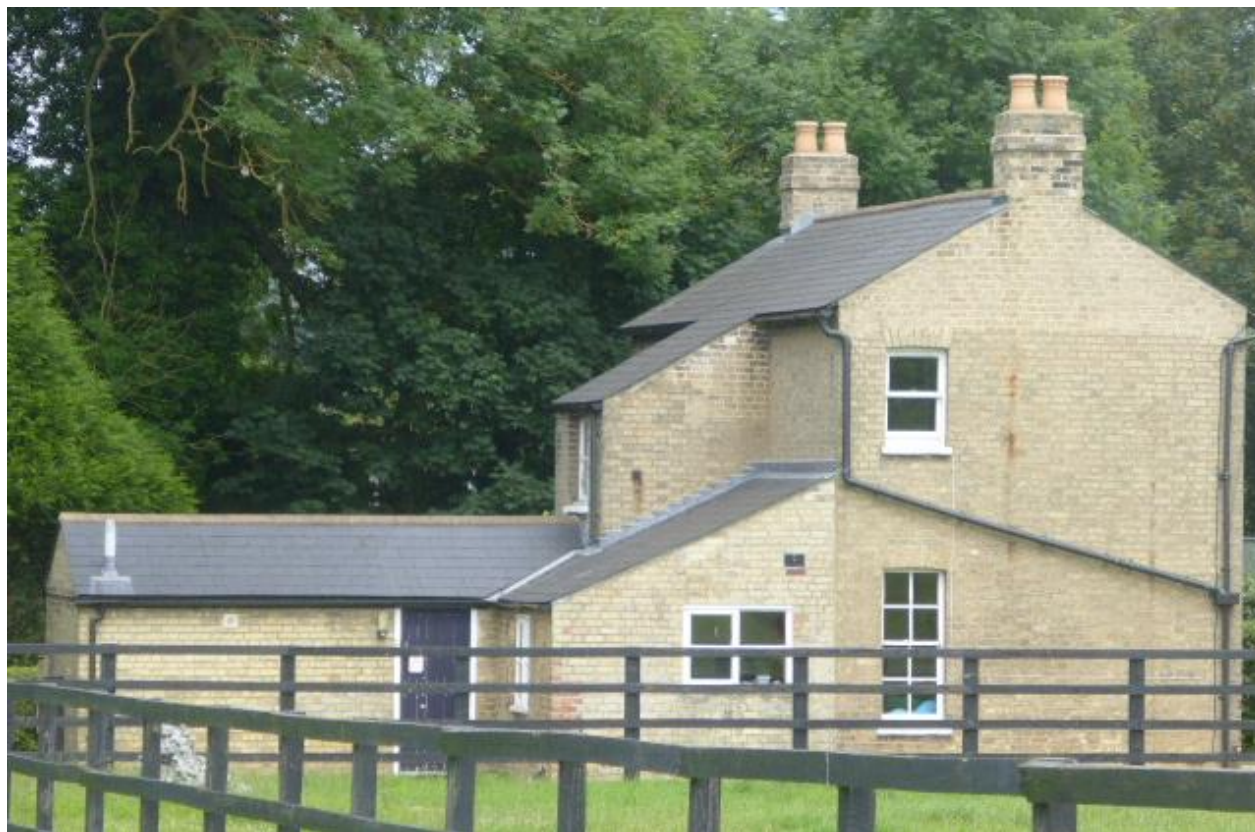
- 4.2.3 The southern and western elevations show evidence of the additions and alterations made to the building (Plate 13). The kitchen lean-to has red brick repairs, a red brick string course, and is faced in machine made brick, with a clear straight joint between it and the original house. A poor quality timber casement window is located in the southern elevation, which contrasts with the sash windows in the original house. A simple timber plank door provides access into the western ablution room extension.

Figure 4.13 Merton Hall Farmhouse from the south west. Note the brickwork showing additions to the rear of the original building

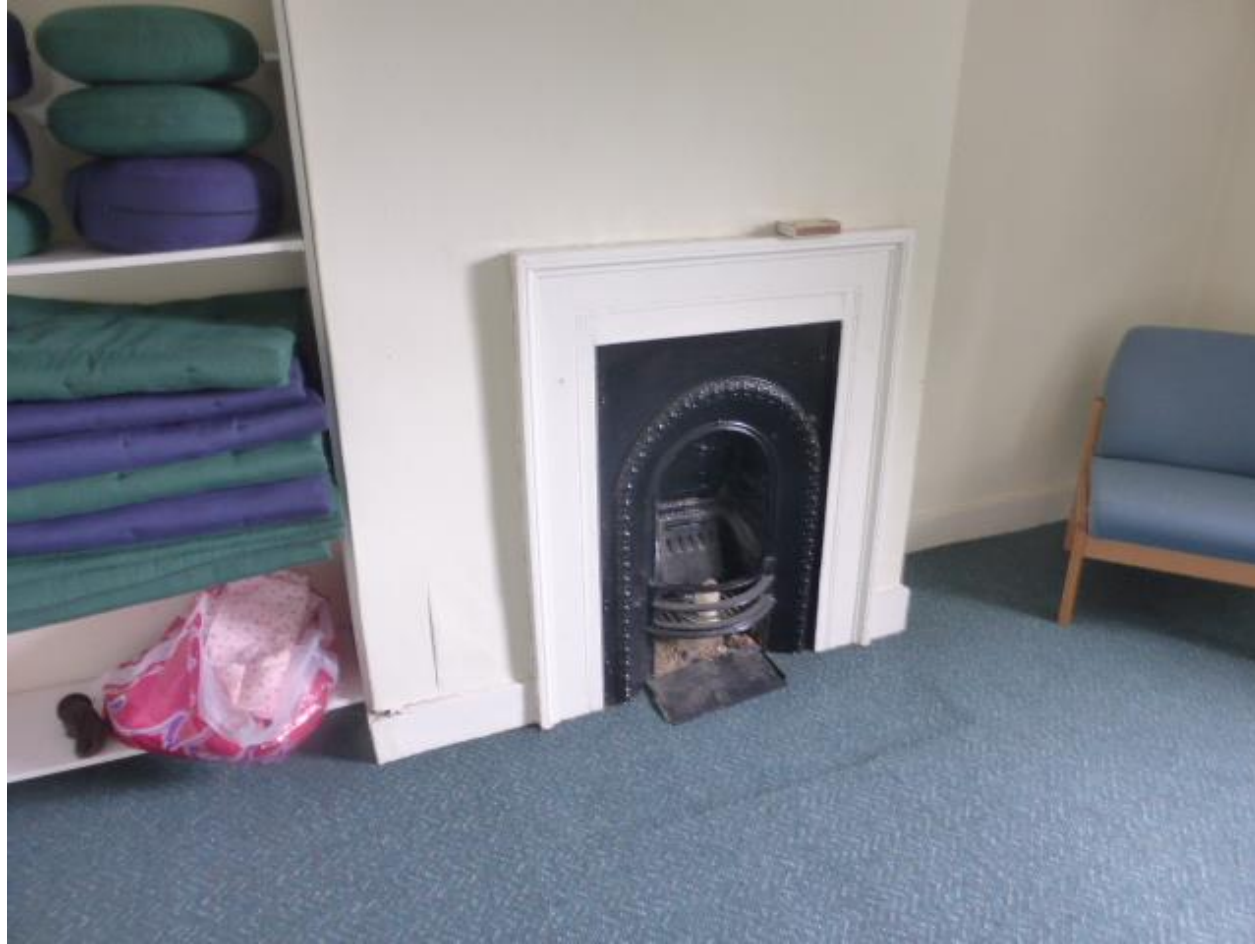
- 4.2.6 The stairs have a cupboard underneath, which appears to be original, although the door is nailed shut. The staircase is timber, with plain newel posts. On the first floor the northern room has a fireplace with a nineteenth century cast iron register grate, with a timber architrave, without a mantelpiece (Figure 4.15). The southern room has a better cast iron fireplace, with a 19th century register grate, implying that this was possibly the principal bedroom, with a timber mantelpiece, though still with a plain skirting board. As with the room below, this is the only room on the first floor to have two windows. The small room, above the ground floor corridor, has a late nineteenth century sash window, and no features of note.

Figure 4.15 Merton Hall Farmhouse, first floor front room (north), showing register grate fireplace

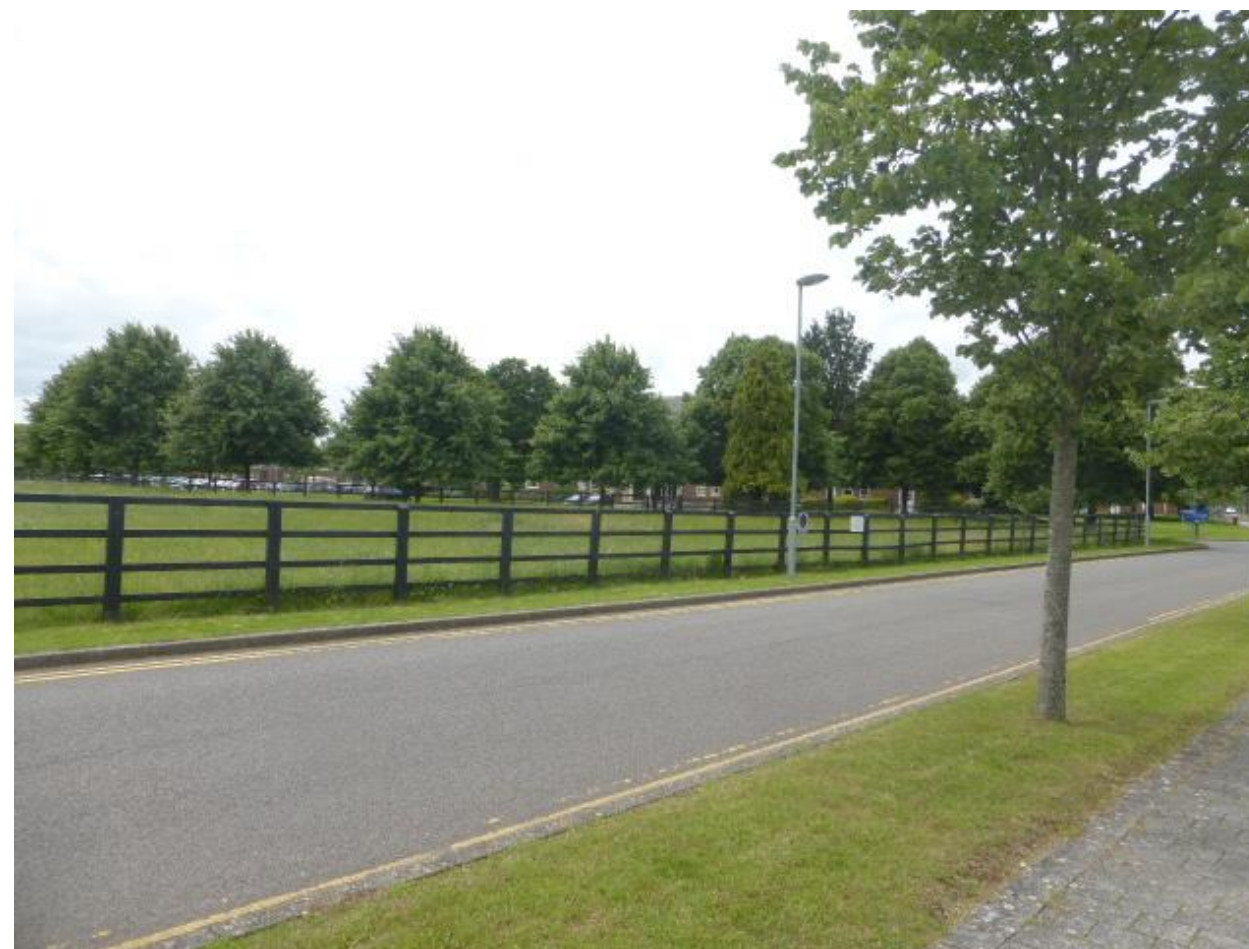
- 5.2.9 The alteration in road layout through the construction of the main West Cambridge entrance along JJ Thompson Avenue has impacted on the setting of the Vet School. Although the original straight approach driveway from the main road, with its avenue of trees survives, it is no longer used, and the character of the approach is much altered. Indeed, from the current approach, the now mature trees along the original avenue screen the department from view (Figure 5.1).

Figure 5.1 Modern day approach to the Vet School, showing screening of approach views due to the road reconfiguration
