WEST CAMBRIDGE

OUTLINE PLANNING APPLICATION

ENVIRONMENTAL STATEMENT _ VOLUME 3

TECHNICAL APPENDICES

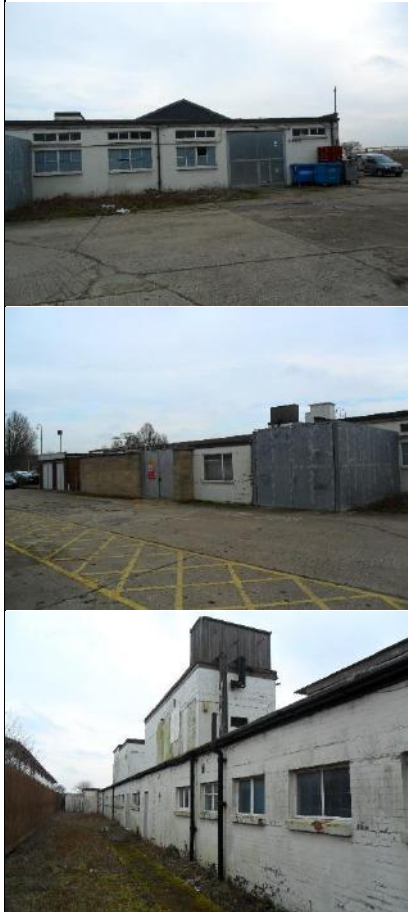
Target Note Number	Description	Photograph
TN1	Laboratory building with low potential to support roosting bats

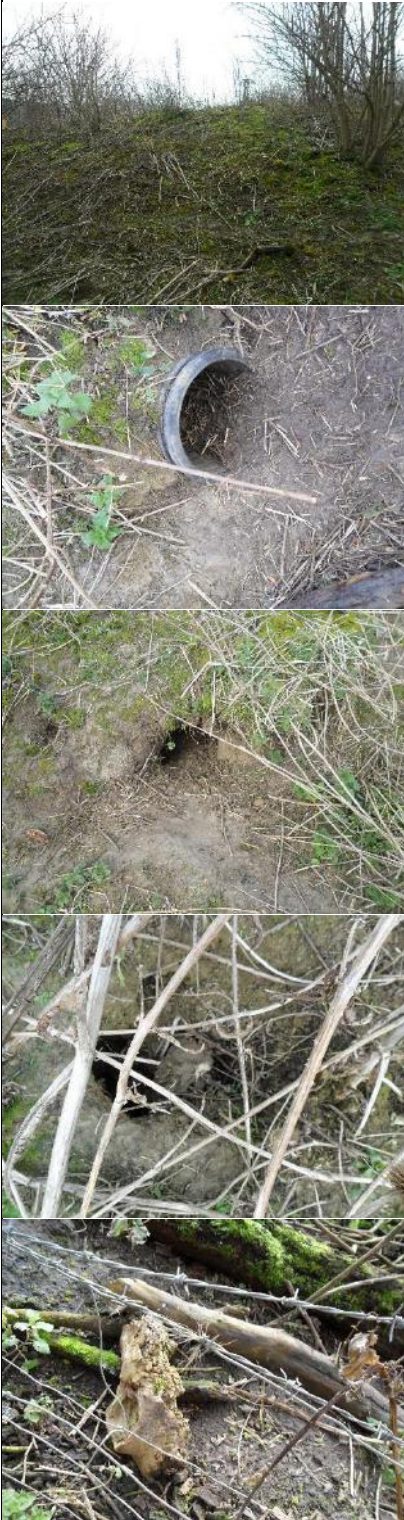
Target Note Number	Description	Photograph
TN2	Artificial Badger sett which has been expanded. Signs of activity around the sett including dung pits, footprints and hair on fencing

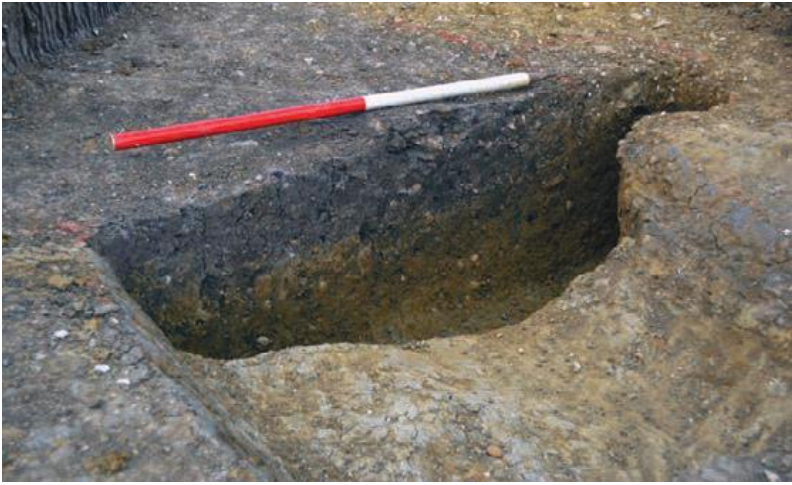
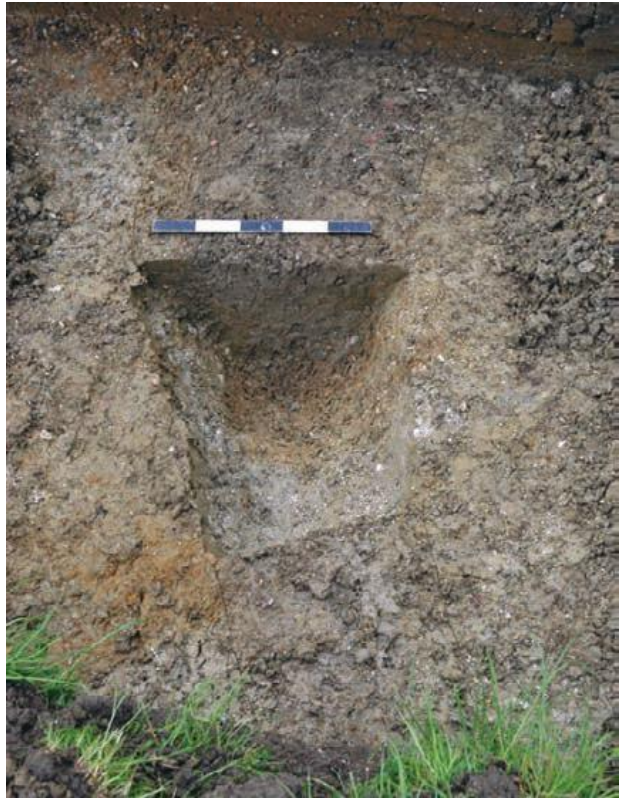
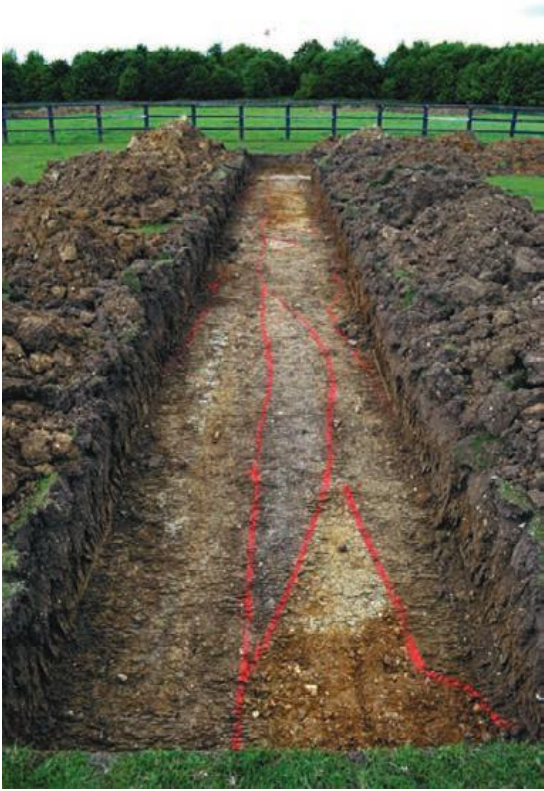
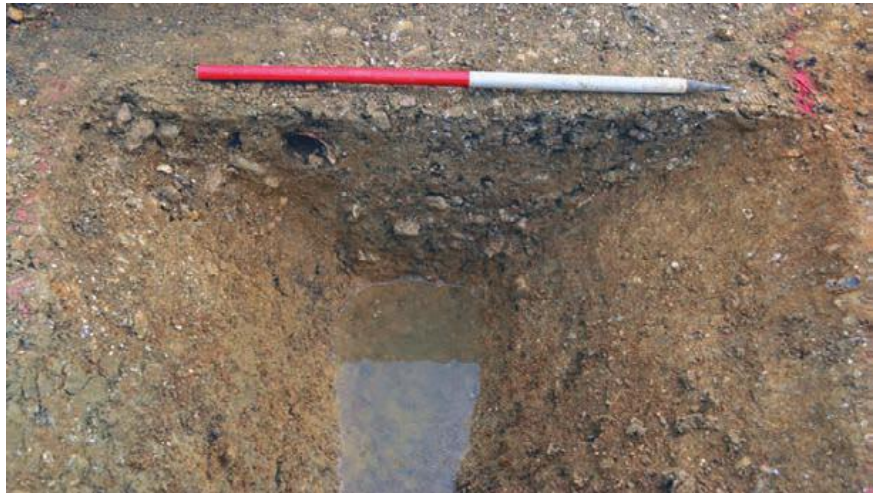
Figure 9. Selected photographs: F.27 and F.28 (top left), F.34 and F.36 (top right), F.29 (bottom right), and Trench 32 (bottom left)
